Lockyer Catchment Action Plan 2015 - 2018

July 2016

Resilient Rivers Initiative

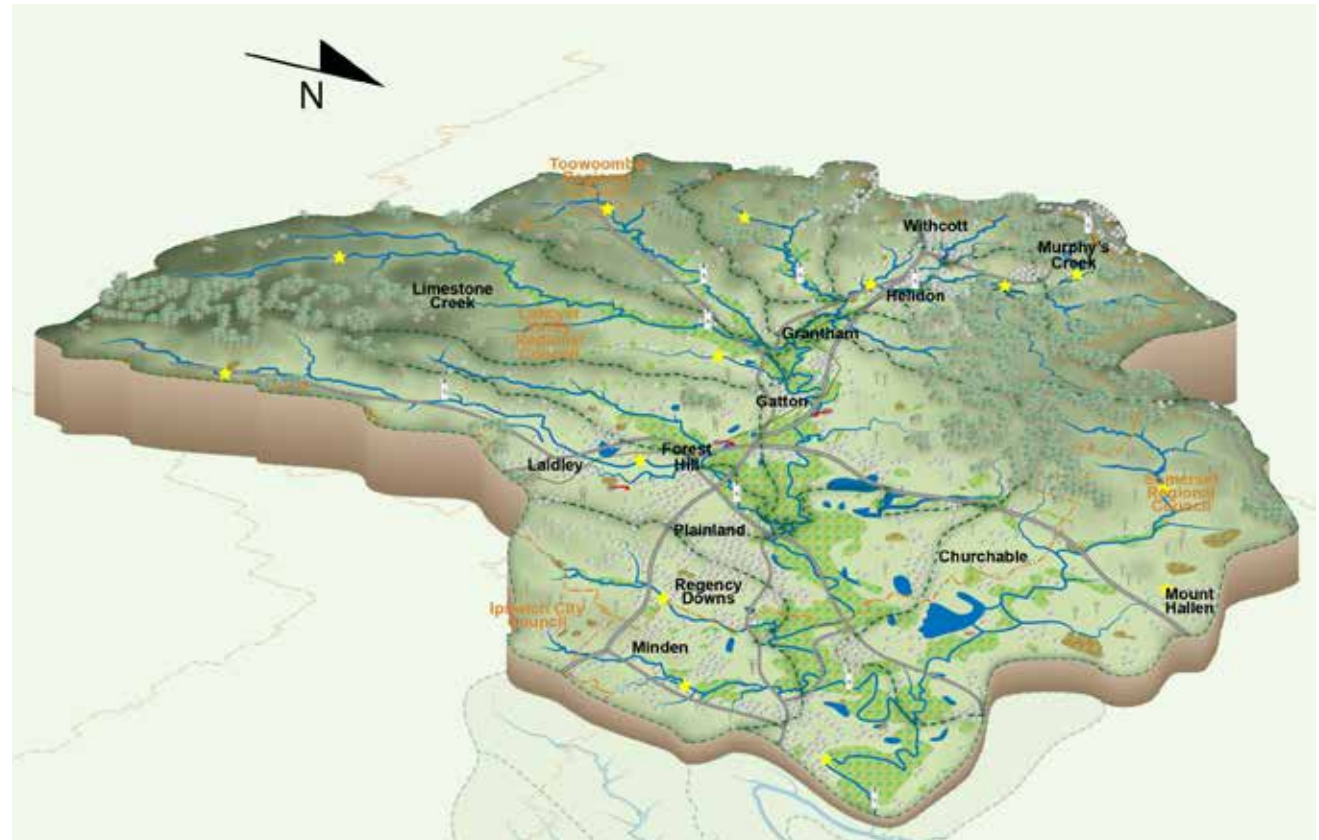
Schematic of the Lockyer Creek catchment

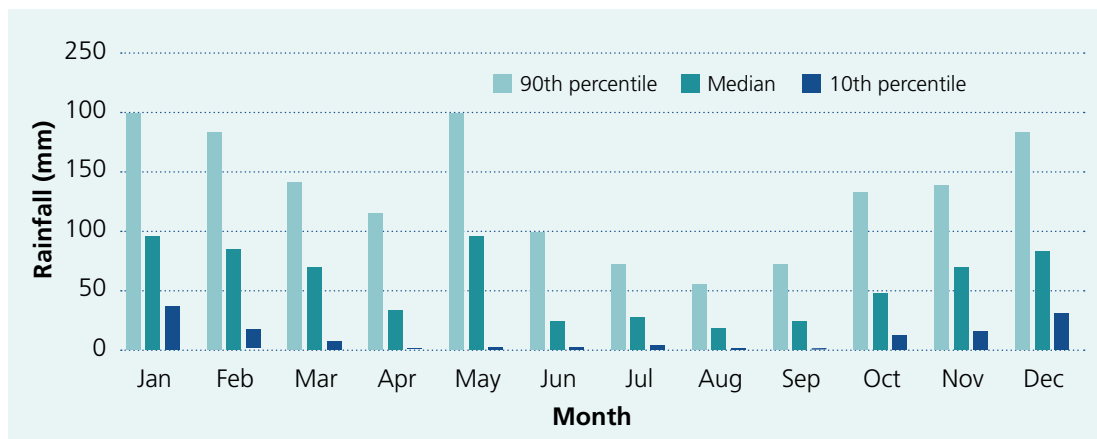
Rainfall data from University of Queensland Gatton gauge (40082) showing the variability in monthly rainfall within the Lockyer catchment (calculated using rainfall totals between 1899 and 2014)

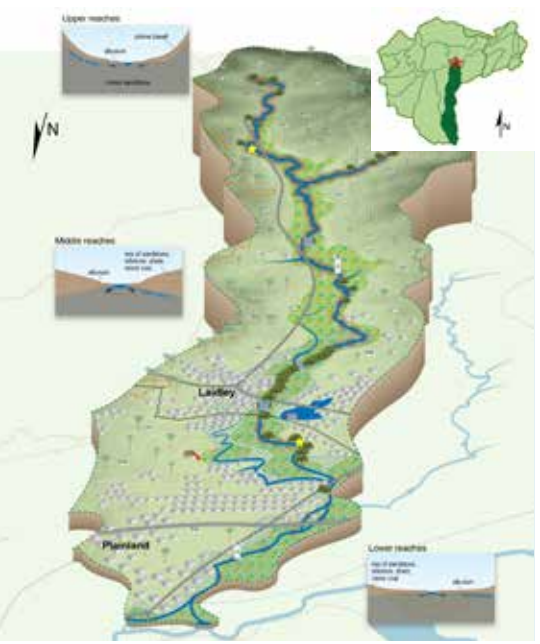
Laidley Creek sub-catchment schematic >

- Laidley Creek**
- Key characteristics:**
- Steep hillslopes with remnant vegetation
 - High energy flows
 - Channel adjustment
 - Secondary channel activation
 - Sediment transfer
 - High quality agricultural land
 - Grazing native vegetation
 - Variable riparian vegetation
 - Assets affected by flooding
 - Dispersive soils
 - Erosion and landslips
 - Downstream surface salinity

The stream bank erosion is a major cause of high turbidity levels within the creek. Laidley Creek has been identified as a significant source of turbidity and nutrients to Lockyer Creek and subsequently the Brisbane River. Additionally, agricultural runoff, the Laidley Sewage Treatment Plant and on-site systems (such as septic tanks) may contribute to water quality issues within the creek.

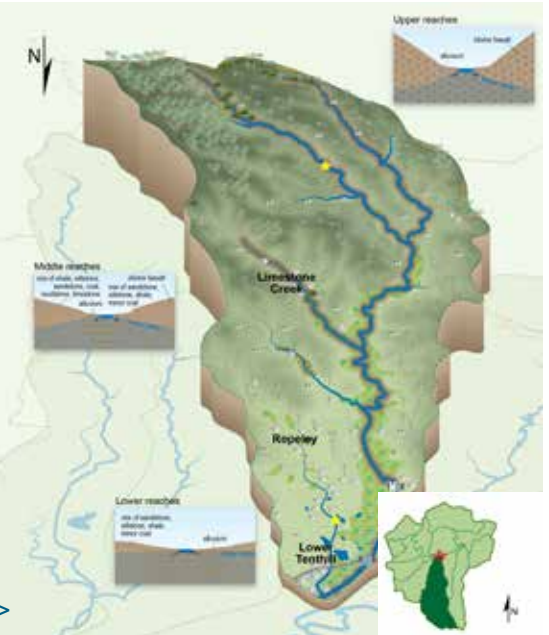
[Tenthill Creek sub-catchment schematic >](#)

- Steep hillslopes and valleys
- High energy flows
- Major channel instabilities
- High quality agricultural land
- Grazing native vegetation
- Residual flood damage
- Sediment transfer
- Dispersive soils
- Erosion and landslips
- Limited riparian vegetation
- Low floodplain resistance
- Infrastructure in creeks
- Main Range National Park

Surface water and groundwater salinity is typically low to moderate except in bores adjacent to Wonga Creek and Deep Gully Creek, where salinity levels are extreme.
